# Aviation Investigation Final Report

<b>Location:</b>	Heyburn, Idaho	<b>Accident Number:</b>	WPR22FA151
<b>Date &amp; Time:</b>	April 13, 2022, 08:32 Local	<b>Registration:</b>	N928JP
<b>Aircraft:</b>	Cessna 208B	<b>Aircraft Damage:</b>	Substantial
<b>Defining Event:</b>	Collision during takeoff/land	<b>Injuries:</b>	1 Fatal
<b>Flight Conducted Under:</b>	Part 135: Air taxi & commuter - Non-scheduled

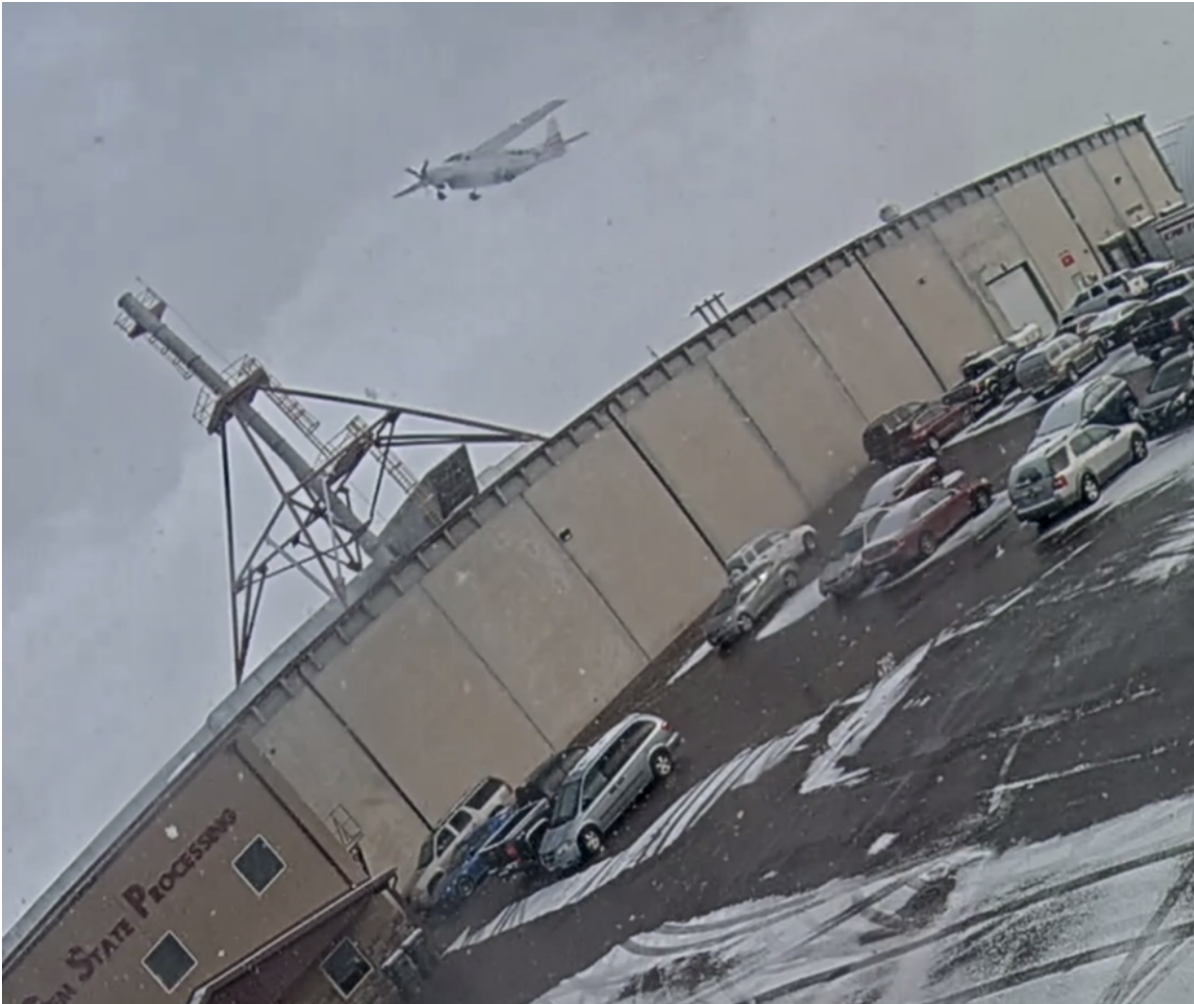
Figure 2. Image from the security camera.

Video footage recovered from a security camera located at the processing plant along the approach to runway 20 showed a view of the rooftop of the processing plant, along with a single vent stack supported by steel framework on the roof. Snow was observed falling, and visible moisture was present in the form of billowing steam clouds emitting from other stacks

on the roof of the plant. The stack remained clearly visible in the video, with small sections periodically concealed by the steam clouds. The stack was topped by a warning light, but due to the daylight contrast, and location of the camera below, it could not be determined if it was operating. About 0832:25, the airplane came into view in a wings-level, flaps-up, nose-high descent (Figure 2). The airplane struck the vent stack and fell to the rooftop. The top of the stack was 4,256 ft msl. The airplane struck the stack about 14 ft below the top. The stack was within the lateral boundaries of the approach path, and the distance from the top of the stack to the glide path above it was calculated at 98 ft (Figure 3).

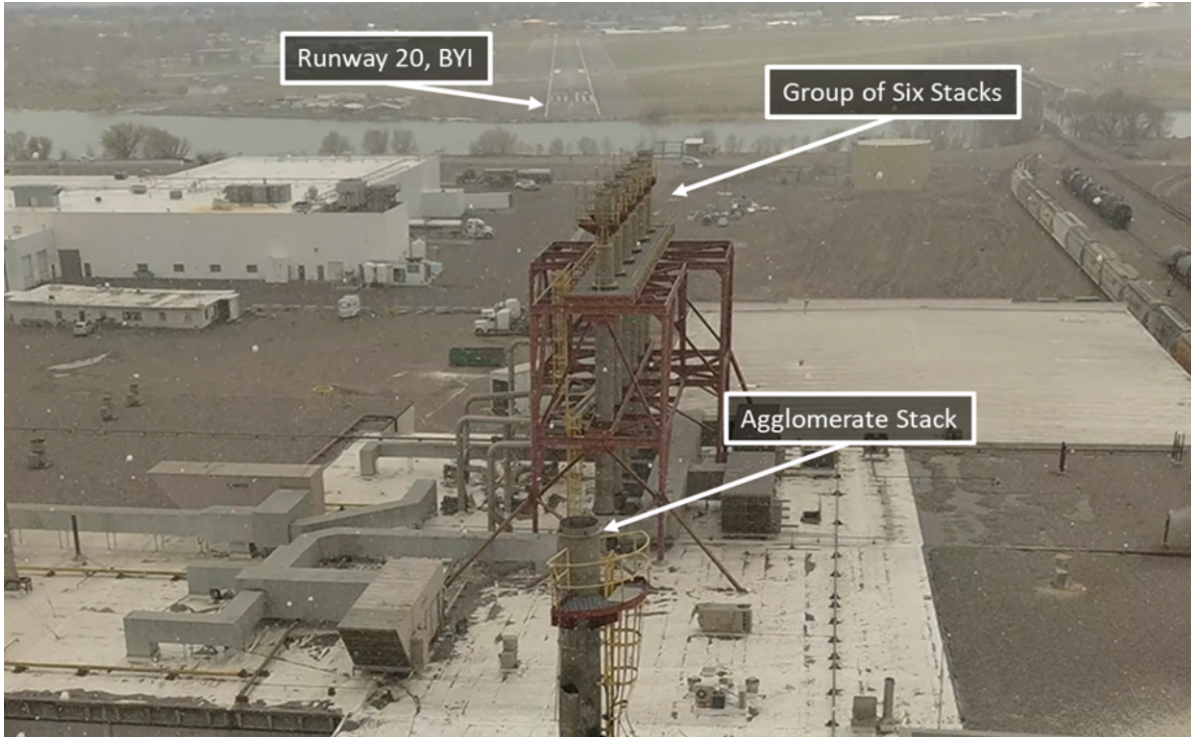
The existing paint scheme and the visible moisture emitted by the stacks provided a low contrast to the environmental background. This low contrast and the lack of a visual glide slope indicator may have caused difficulty for the pilot in maintaining a safe altitude during the visual portion of the approach to the runway. A white and aviation orange paint scheme, as identified in the regulations, may have offered a higher contrast and thus an adequate warning once the pilot transitioned to visual conditions.

Figure 9. Image of the Gem State Processing plant roof top. The agglomerate stack and the group of six stacks are in view. Photo courtesy of the Hayburn Police Department.

The NTSB asked for clarification as to whether the stacks in question were required to be both marked and lighted in accordance with FAA Advisory Circular 70/7460-1. The FAA confirmed that “as a condition of the No Hazard Determination, dated February 2, 2017, the stacks were required to be painted with white and aviation orange paint, and lit with red obstruction lights, per FAA Advisory Circular 70/7460-1.” The NTSB noted during the investigation that neither the agglomerate stack nor the six drum dryer stacks were painted with white and orange aviation paint. Each stack in the group of six stacks had a red aircraft warning light.

The agglomerate stack was equipped with an aircraft warning light; however, the light was stolen before it could be examined by the NTSB. The Heyburn Police Department investigated the theft but was unable to recover the light. According to the police report, an individual was found to have trespassed on the property of Gem State Processing after the accident. This individual later published a YouTube video where he reported to have taken the light from the accident site. When questioned further about the location of the light, the individual recanted and stated that he had essentially made the video for dramatic effect, and while he examined the light at the accident site and removed it from its conduit, he had not taken it away. The Heyburn Police Department report, along with a copy of the YouTube video are included in the public docket. Examination of the video appeared to indicate that the light was the same type as initially observed at the accident site and bore similar labels along with signatures of possible damage that matched the accident light.
