Aviation Investigation Preliminary Report

Location: Selden, KS **Accident Number**: CEN24FA243

Date & Time: June 30, 2024, 17:52 Local Registration: NS14137

Aircraft: Waco YKC Injuries: 2 Fatal

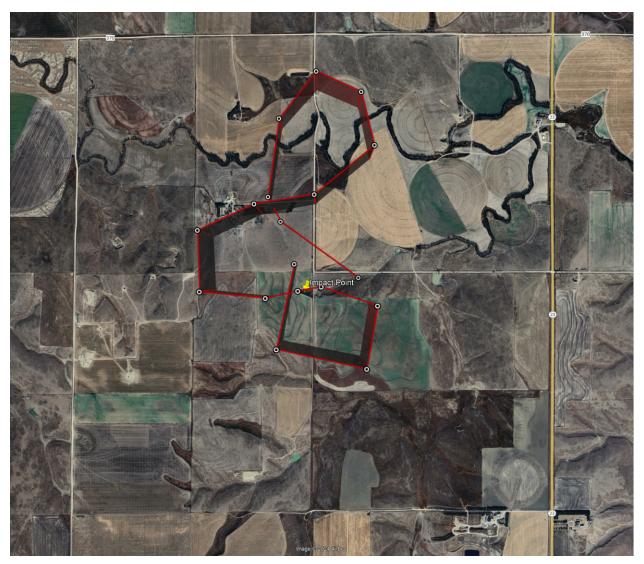
Air Traffic Control (ATC) radar data, beginning at 1746:09, showed the airplane make several climbing turns starting at an altitude of 3,025 ft mean sea level (MSL) to a maximum altitude of 4,625 ft MSL over the accident site. The data then showed the airplane begin a descending right bank, before data was lost at 1748:54 on a heading of 075°, at 109 knots groundspeed, and an altitude of 3,800 ft MSL, which was about 1,050 ft above ground level (See figure 1).

Figure 1. ATC radar data flight track.

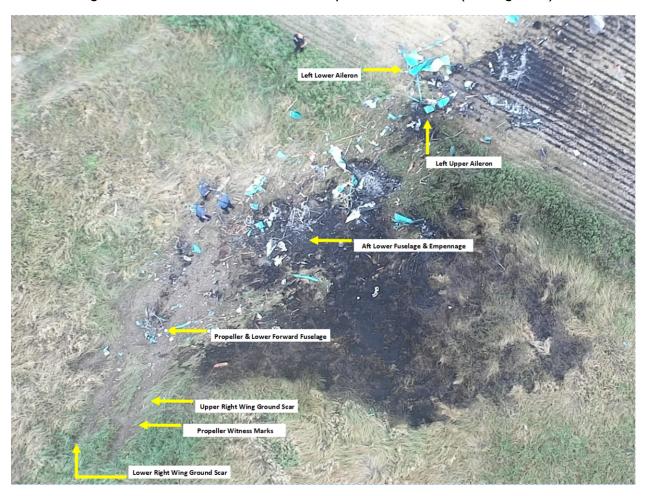
The accident site was in a relatively flat agricultural field about .10 nautical miles southeast of the last received ATC radar position. Impact marks and debris were consistent with the airplane impacting the terrain in about a 90° right bank and about 40° nose down attitude. The

debris field was about 526 ft in length and 67 ft in width on a heading of about 183° continuing to a heading of about 228° with evidence of a postaccident fire (See figure 2).

Figure 2. Accident debris field. (Aerial photograph courtesy of the Sheridan County Sherriff Office)
