Aviation Investigation Preliminary Report

Location:	Newberg, OR	Accident Number:	WPR24FA004
Date & Time:	October 3, 2023, 18:47 Local	Registration:	N8360K
Aircraft:	Piper PA-44-180	Injuries:	2 Fatal, 1 Serious
Flight Conducted Under:	Part 91: General aviation - Instructional

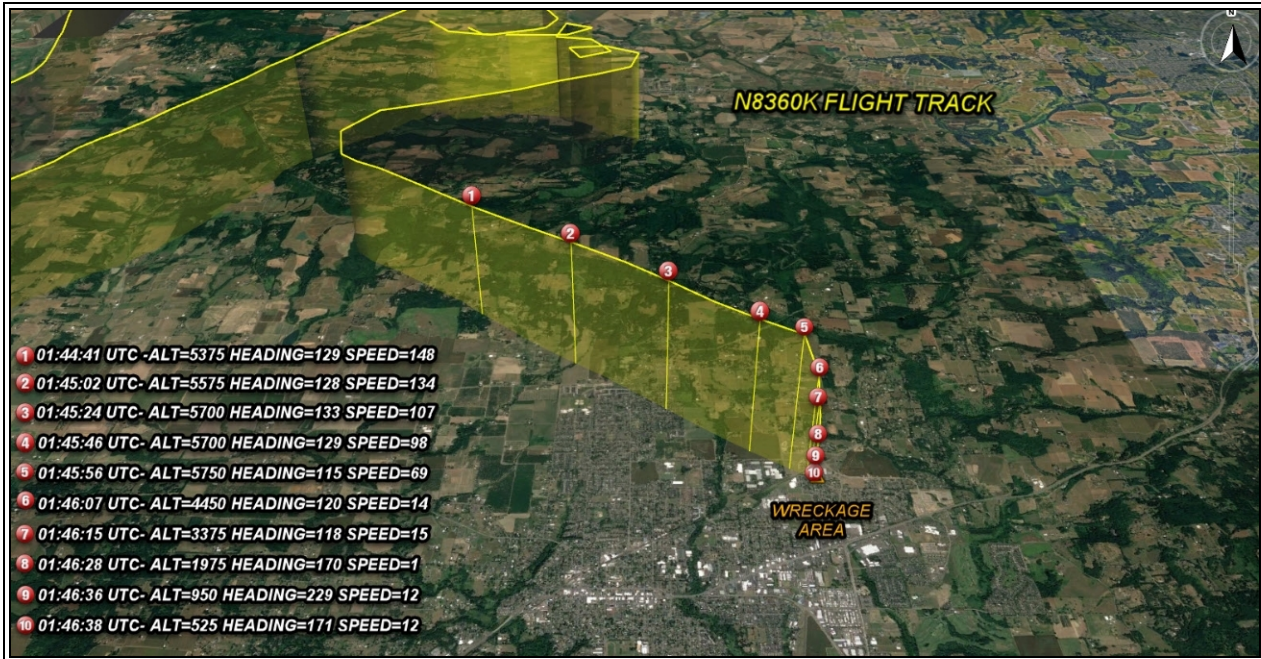
Recorded Automatic Dependent Surveillance-Broadcast (ADS-B) data provided by the Federal Aviation Administration (FAA) showed that the airplane departed Portland-Hillsboro Airport (HIO) at 0118:21 and ascended to 1,200 ft mean sea level (msl) before a left turn was initiated. The airplane continued on a western heading and ascended to an altitude of about 3,400 ft msl. At 0125:35 the airplane made a left turn to the south and ascended to an altitude of 5,300 ft msl. At 0130:46 the airplane made a left 180° turn to the north, then made a right turn to the northeast. The data showed the airplane continued on a northeast heading for about 3 minutes, before a series of 360° turns to the left and right were performed. At the completion of the turns, the airplane turned to the southwest. The data showed that at 0143:48, the airplane made a left turn to the southeast. While on a southeasterly heading, the airplane's ground speed began to decrease from 133 kts. At 0145:56 the data showed the airplanes ground speed had decreased to 69 kts, at an altitude of 5750 ft msl, and began to descend on a southeasterly heading. The last recorded ADS-B target, at 0146:38, was located about 50 ft northwest of the accident site at an altitude of 525 ft, as seen in figure 1.

Figure 1: View of accident airplane flight track.
