Aviation Investigation Preliminary Report

Location:	Scottsdale, AZ	Accident Number:	WPR25FA088
Date & Time:	February 10, 2025, 14:38 Local	Registration:	N81VN
Aircraft:	GATES LEARJET CORP. 35A	Injuries:	1 Fatal, 3 Serious, 1 Minor
Flight Conducted Under:	Part 91: General aviation - Executive/Corporate

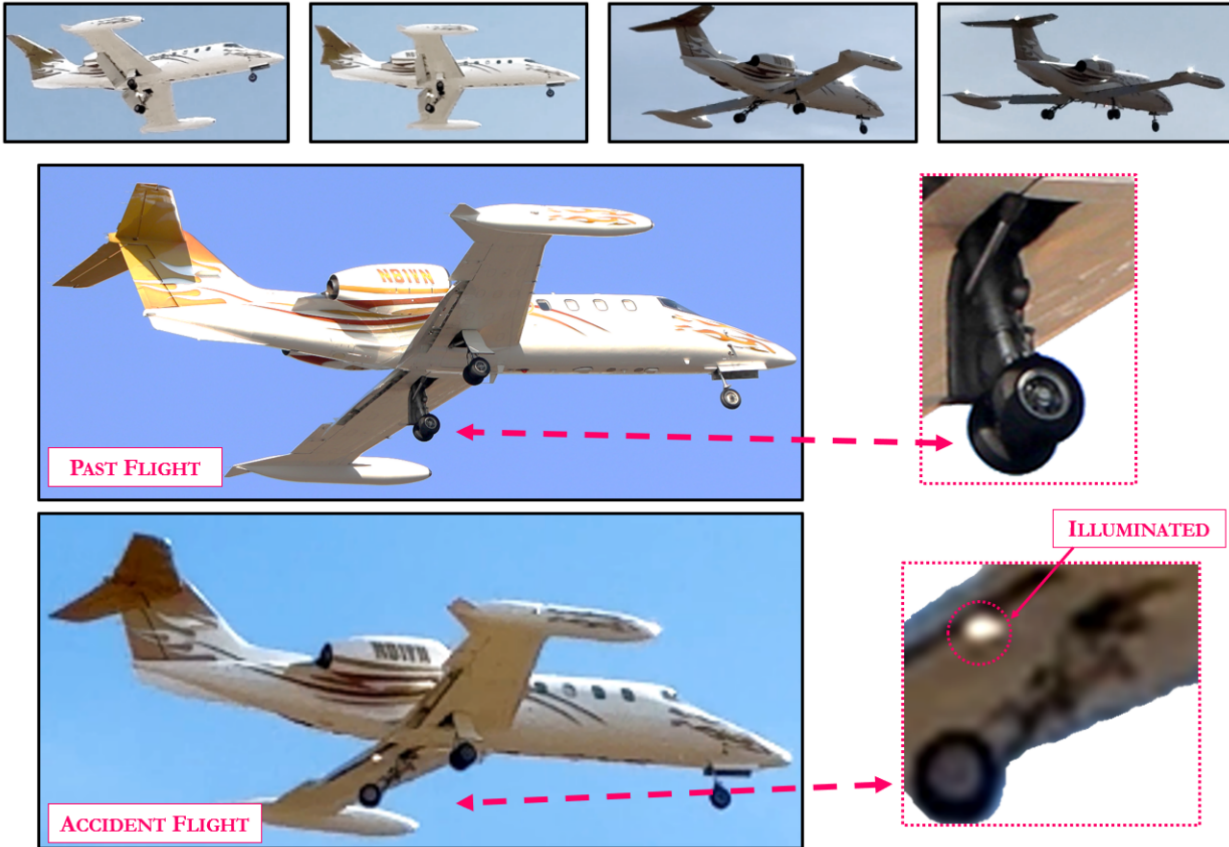
Investigators obtained security camera footage and numerous videos from personal cell phone cameras. A witness provided video taken from a golf course near the final approach path that captured the airplane for 11 seconds starting at 1437:52. The airplane can be seen on final approach with the left landing gear trailing aft from its normal position. Additionally, there is a circular bright spot seen above the landing gear strut, consistent with the landing gear light illuminating the bottom of the wing flap and the landing gear strut positioned facing aft (see figure 1).

Figure 1: Excerpts from a witness supplied video showing the left landing gear askew while on approach to the runway. (Past Flight Photo Source: www.jetphotos.com)

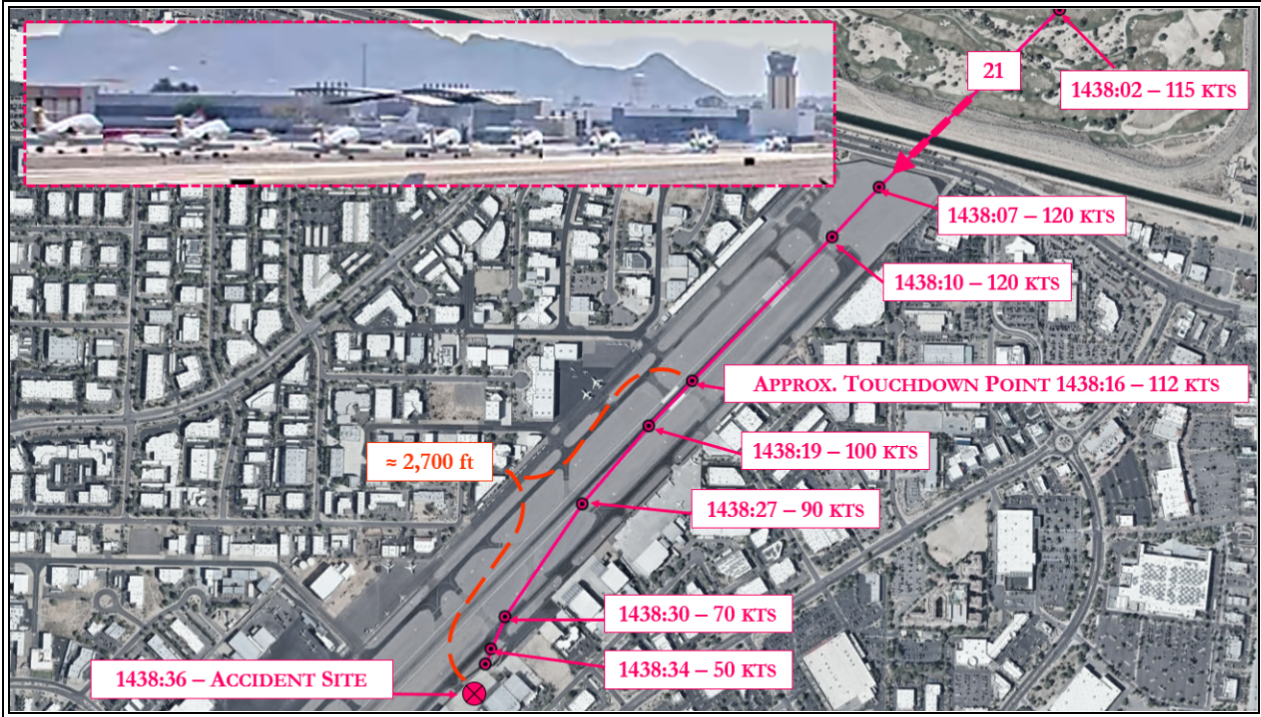
A review of surveillance videos and ADS-B data showed that at 1438:16, the airplane touched down on runway 21 just before the aiming point markings with full flaps extended. It immediately entered a left-wing-low attitude and began veering left, exiting the runway surface. The airplane traveled over the rock-covered runway-safety-area islands located between the runway and taxiways. The airplane crossed Taxiway Bravo, collided with the windsock, and entered the ramp area where it struck the right side of a parked Gulfstream G200 (see figures 2 and 3). The airplane was not equipped with thrust reversers and the drag chute was not deployed.

Figure 2: ADS-B derived flight path and groundspeeds with video excerpts showing the airplane at touchdown

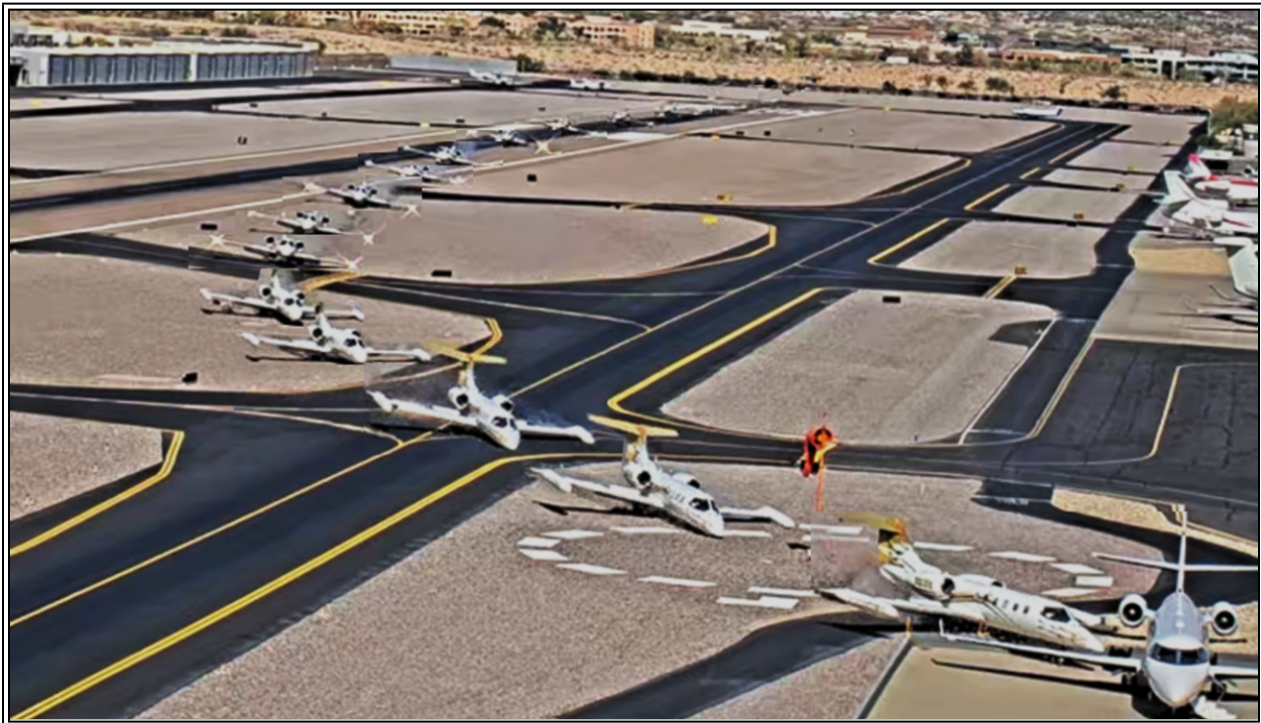
Figure 3: Video excerpts showing the landing rollout to impact

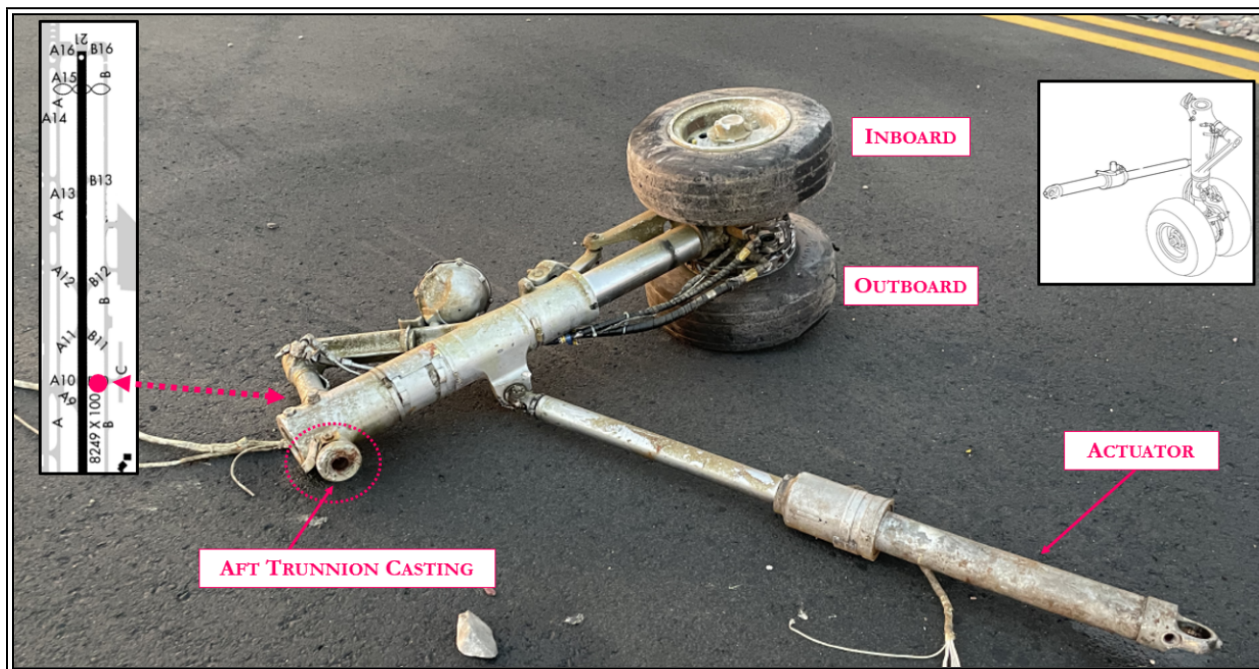
The left main landing gear came to rest on Taxiway Bravo 10 adjacent to Taxiway Bravo (see figure 5). The forward trunnion pin remained secured in the forward trunnion casting. The aft trunnion pin was

Figure 5: Left main landing gear at the accident site

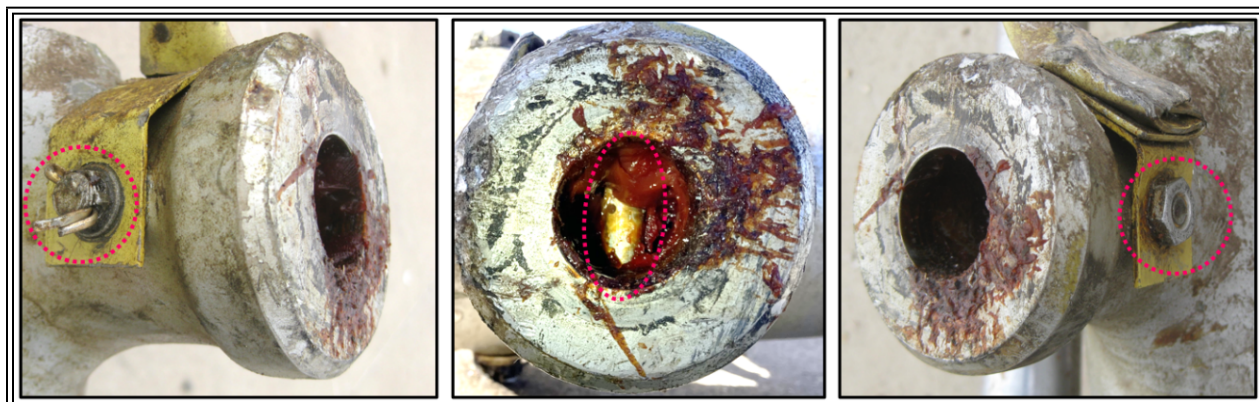
not present within the trunnion casting, though the retaining bolt with striker bracket was secured with the castle nut and cotter pin (see figure 6). The actuator remained connected to the strut, but the inboard attachment point was no longer fastened to the airframe. The right main landing gear remained attached to the airframe and was in the down and locked position with the outboard gear door separated and located within the debris field and the inboard door in the locked position.

Figure 6: Left main landing gear aft trunnion casting at the accident site

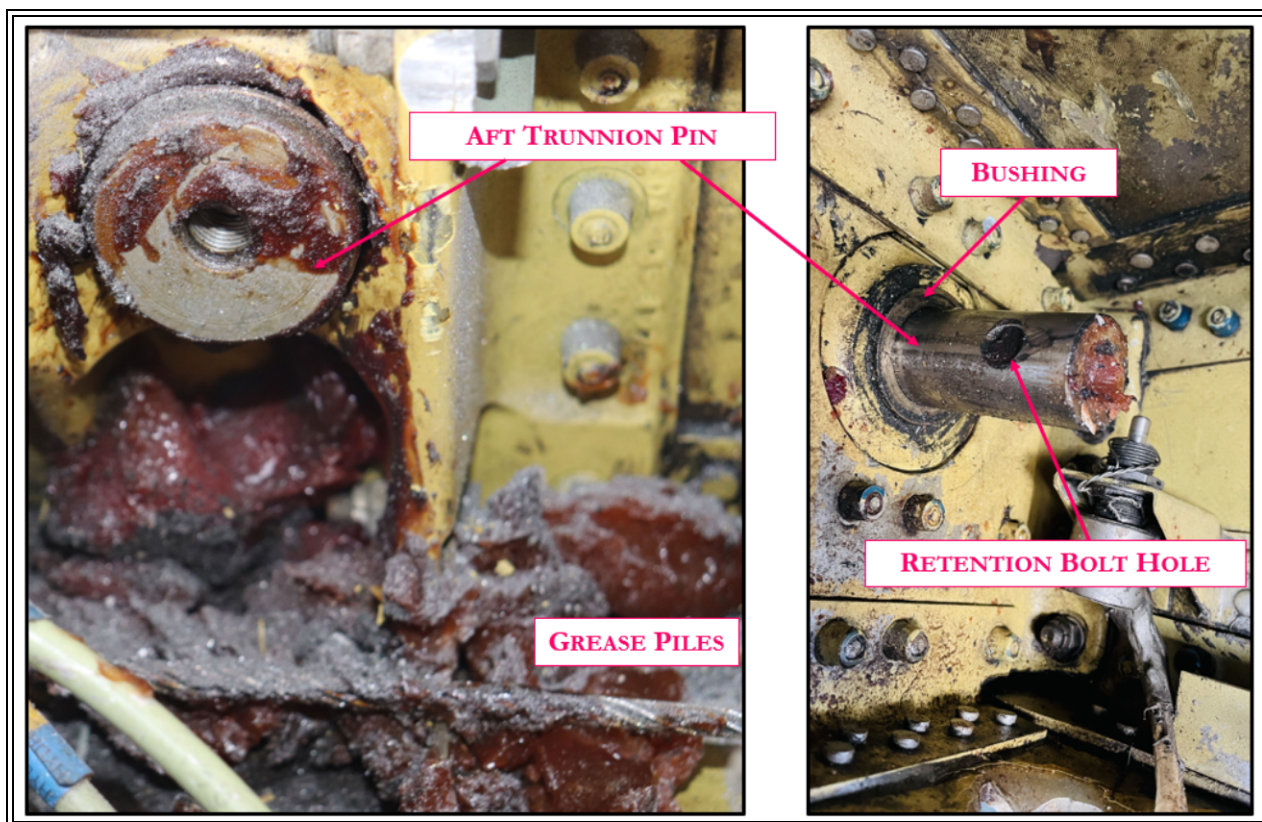
The left outboard gear door was not located. The inboard landing gear door was not in the uplock position. Examination of the left wheel well revealed that the aft trunnion pin was still in the aft trunnion fitting (located on spar #7) with no forward shims located. Removal of the access panel adjacent to the aft trunnion fitting gave investigators visual access to the aft trunnion pin's shoulder and the aft shims. There was an excessive amount of grease piled below the pin (see figure 7).

Figure 7: Left main landing gear aft trunnion pin

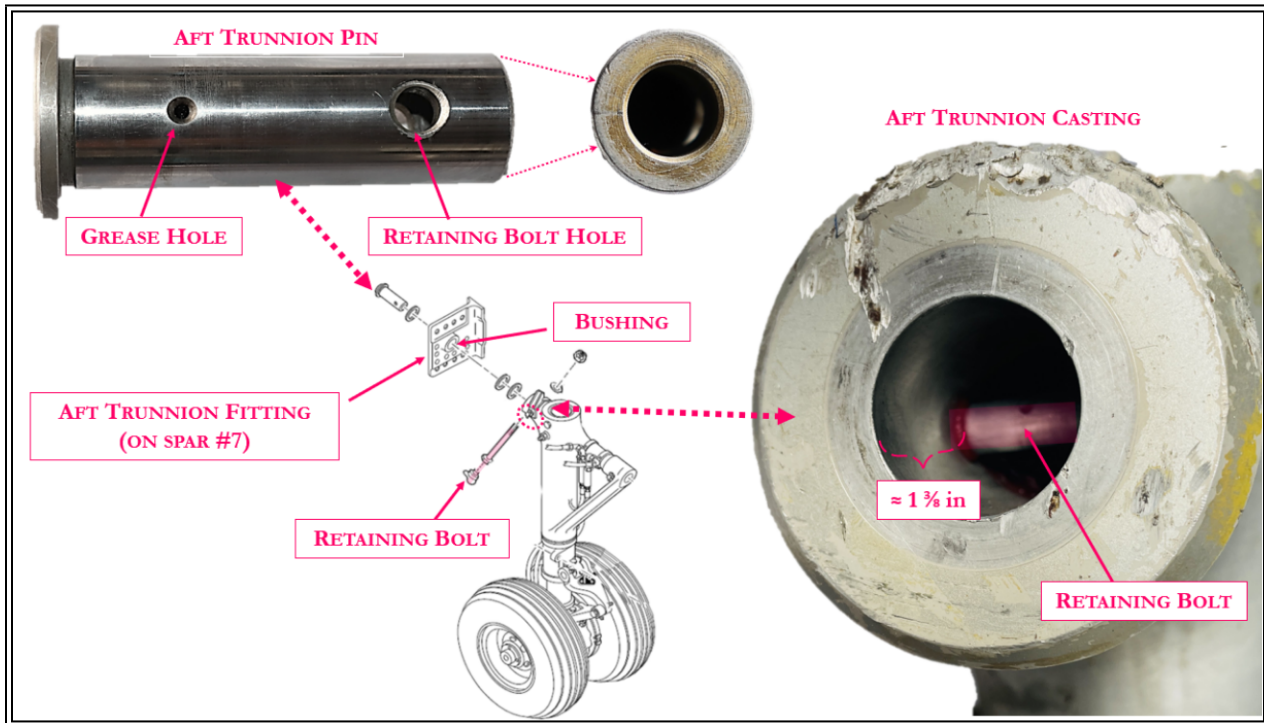
The Learjet manual specifies that installation of the main gear strut begins by securing the forward trunnion pin. The mechanic then should raise the shock strut so that the forward trunnion pin engages in the forward bearing. Thereafter, the mechanic should align the trunnion with the aft trunnion fitting. The same number of shims as previously removed should be placed onto the aft trunnion pin before inserting it from the aft side of spar 7 and then into the trunnion casing, ensuring all shims remain undamaged. A temporary bolt is installed on the shoulder area of the aft trunnion pin to check tolerances, after which the bolt is removed to insert the striker bracket. Finally, the mechanic secures the retaining bolt (with attached Zerk fitting) through the aft trunnion pin and trunnion casing with a nut and cotter pin on the other side. The mechanic then must check the tolerance between the aft trunnion casing and aft trunnion fitting. Thereafter, grease is added through the Zerk fitting to migrate through the pin and grease the bushing through the grease hole (see figure 8).

Investigators took measurements of the aft trunnion pin shoulder protrusion off the aft trunnion fitting if it was not engaged fully forward into the trunnion casing. If the bolt is secured before engaging the

pin in the trunnion casing then the grease hole could be aft of the bushing allowing grease to escape outside the pin, into the wing bay behind spar #7. With the adjacent access panel removed, using a mirror, the pin can visibly be seen not making contact with the aft trunnion fitting when it is not fully pushed into the trunnion casing. The NTSB is aware of at least three other prior events where a Learjet landing gear had disconnected from the airframe because the retaining bolt was not engaged through the aft trunnion pin.

Figure 8: Left main landing gear aft trunnion pin showing bolt installed.
