# Aviation Investigation Preliminary Report

<b>Location:</b>	Twisp, WA	<b>Accident Number:</b>	WPR24FA001
<b>Date &amp; Time:</b>	October 1, 2023, 10:30 Local	<b>Registration:</b>	N56DV
<b>Aircraft:</b>	CUBCRAFTERS INC CCK-1865	<b>Injuries:</b>	1 Fatal
<b>Flight Conducted Under:</b>	Part 91: General aviation - Personal

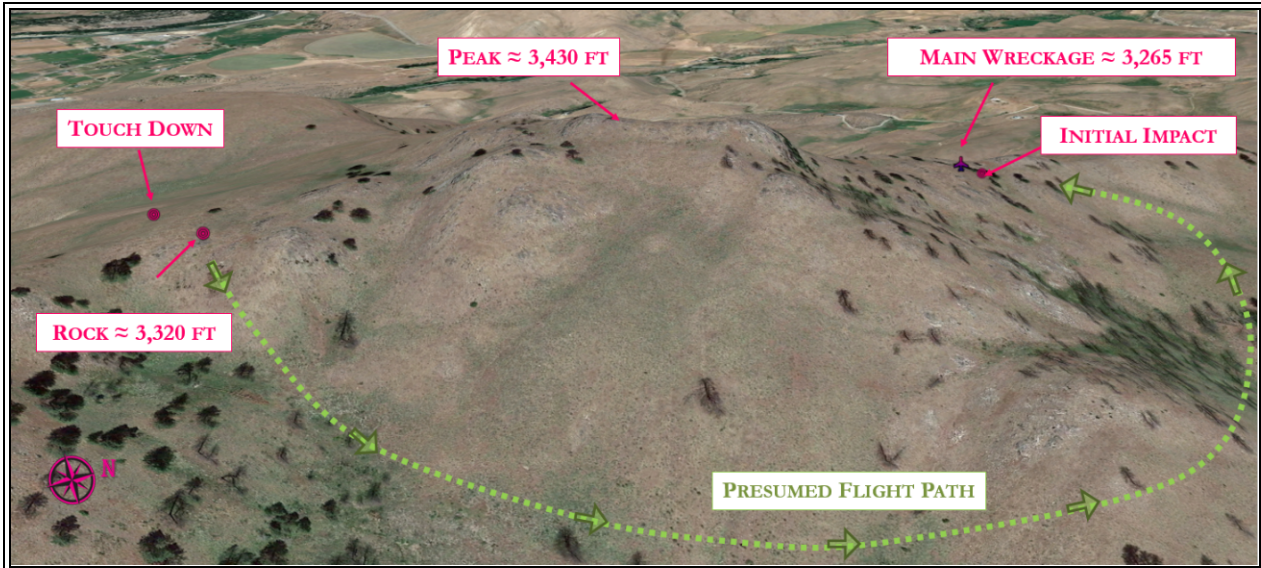
The friend observed the airplane continued over the ridge to the east (the presumed bail-out path) and then he lost sight. He asked the pilot if he was okay and the pilot replied “I’m flying, but I’m having problems.” The airplane collided with terrain shortly thereafter. The airplane came to rest about 1,700 ft to the northeast of the rock with an approximate 3,430 peak between the locations (Figure 1).

Figure 1: Initial Landing Area in Reference to the Accident Site

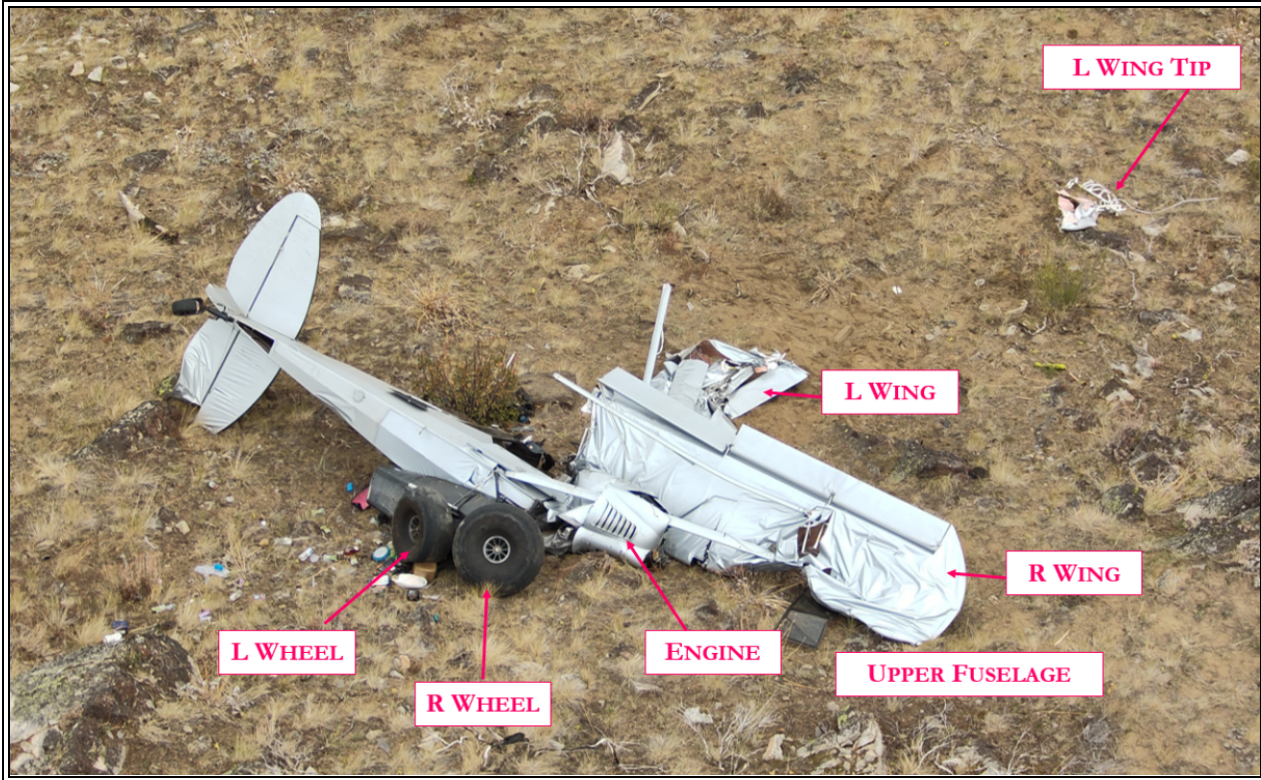
The fuselage came to rest on its left side with the right wing folded forward over the engine (see Figure 2). The left wing sustained crush deformation and came to rest inverted. The left forward and aft lift struts had separated, but remained attached to their respective fittings on the fuselage and wing. An approximate 1.5 ft piece of the left aft-lift strut remained attached to the airframe; the trailing edge of both portions of that strut contained black marks consistent with the rubber from the tire. The flaps appeared to be partially down and the fuel selector was in the off position (it could not be confirmed if this was done by first responders).

Figure 2: Wreckage

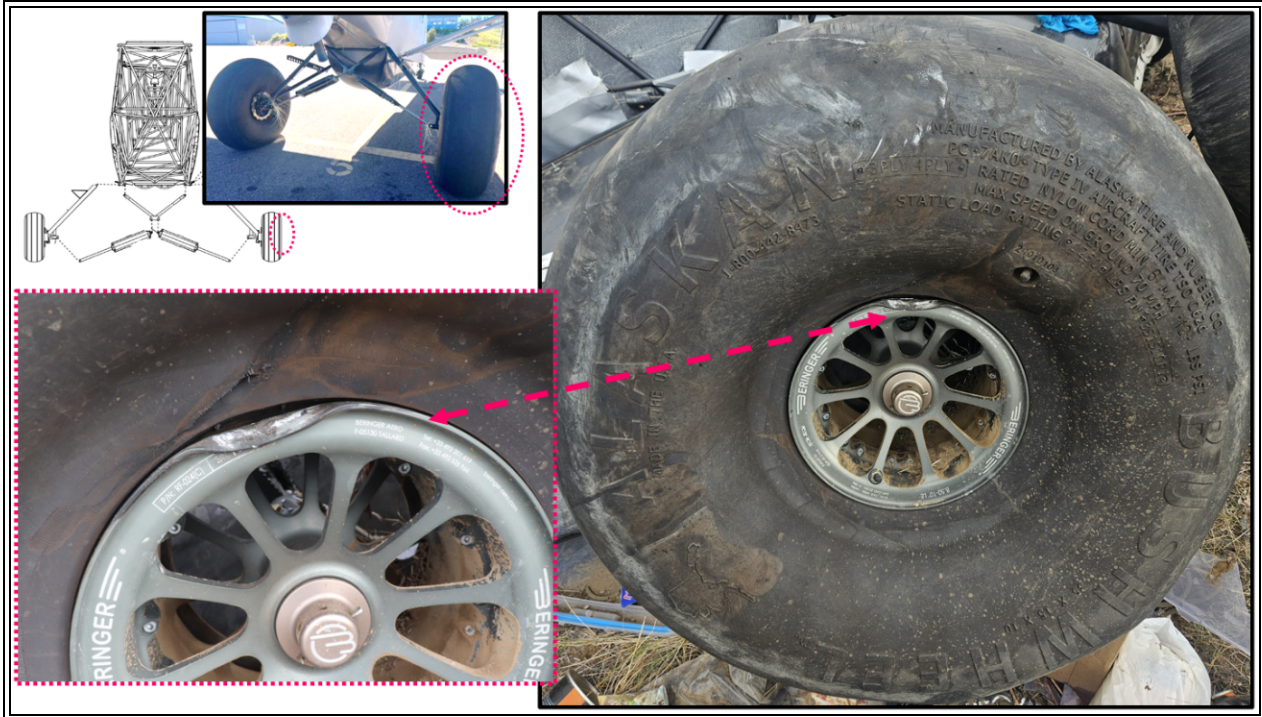
Both tires came to rest on near the belly pod. The left tire was flat and showed several gouges and scrapes on the rubber; the metal hub was bent and folded over itself in one area (see Figure 3). The landing gear struts were collapsed the bottom of the left struts were separated and appeared to have been worn from being dragged across terrain.

Figure 3: Left Tire

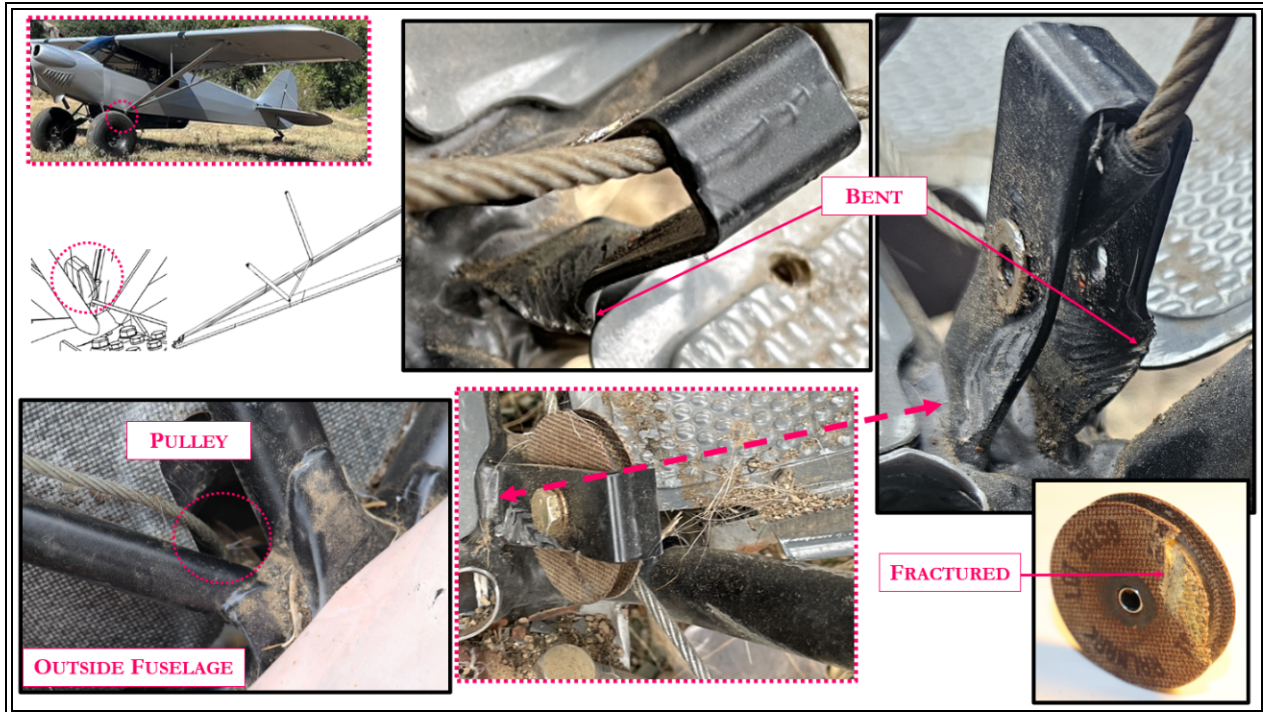
The fuselage frame behind the left lift-strut fork and gear-strut connection fittings was deformed. The left-aileron pulley, located adjacent to the deformed frame, would not move. The aileron cable was trapped between the frame and the pulley and could not move (see Figure 4). Removal of the pulley hardware revealed that pulley bracket was bent and there was evidence of the cable rubbing against the bracket and part of the airframe. The phenolic pulley had a groove for the cable that extended around the pulley. The groove contained a peak edge on each side. One side of the peak edge was fractured, consistent with overstress. The side face of the pulley, adjacent to the fractured peak edge) contained a long, imprinted streak consistent to the location where the cable had pulled out/de-railed from the groove.

Figure 4: Left Aileron Pulley

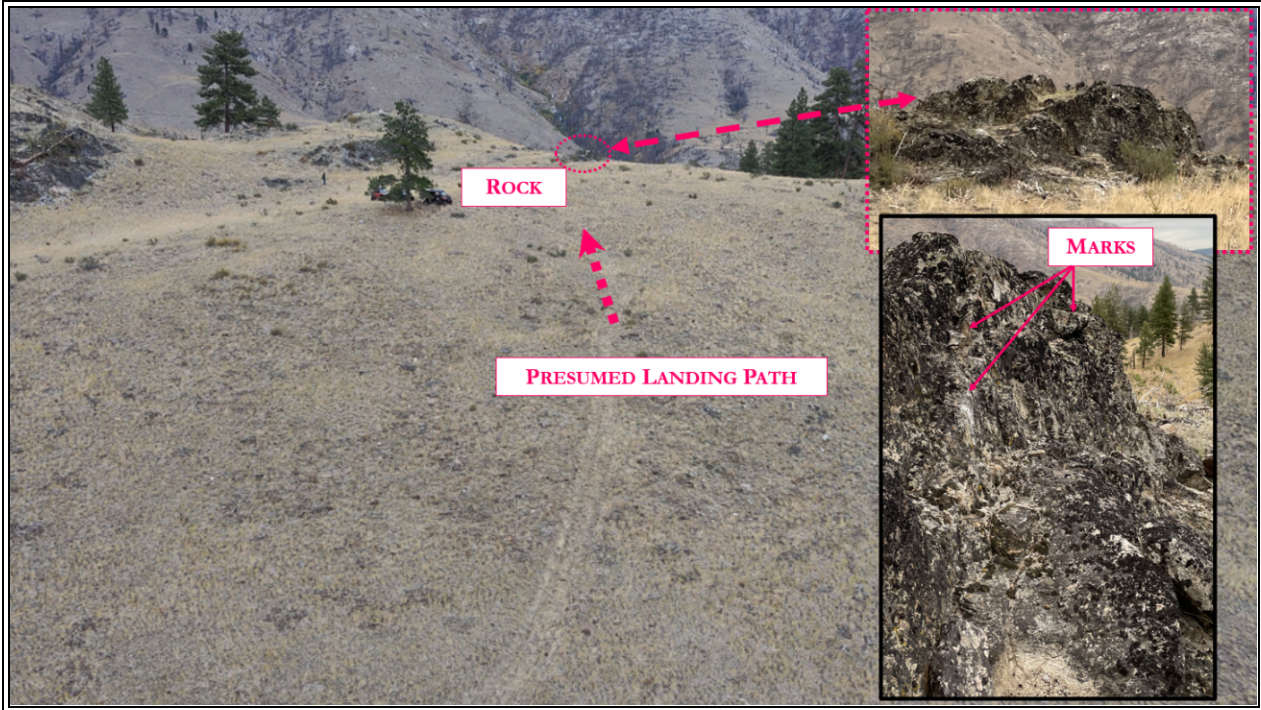
The initial touchdown area could not definitely be determined, but tracks in the dry grass were found on the slope consistent with the landing direction. A large rock was located on the saddle of the hill. There were numerous marks and scrapes found on the south rock face and on the top of the rock (see Figure 5). In the surrounding area, there was several silver chips of paint and a zip-tie that would have been on the landing gear.

Figure 5: Accident Site Overview
