Aviation Investigation Preliminary Report

Location:	Scottsdale, AZ	Accident Number:	WPR25FA088
Date & Time:	February 10, 2025, 14:38 Local	Registration:	N81VN
Aircraft:	GATES LEARJET CORP. 35A	Injuries:	1 Fatal, 3 Serious, 1 Minor
Flight Conducted Under:	Part 91: General aviation - Executive/Corporate

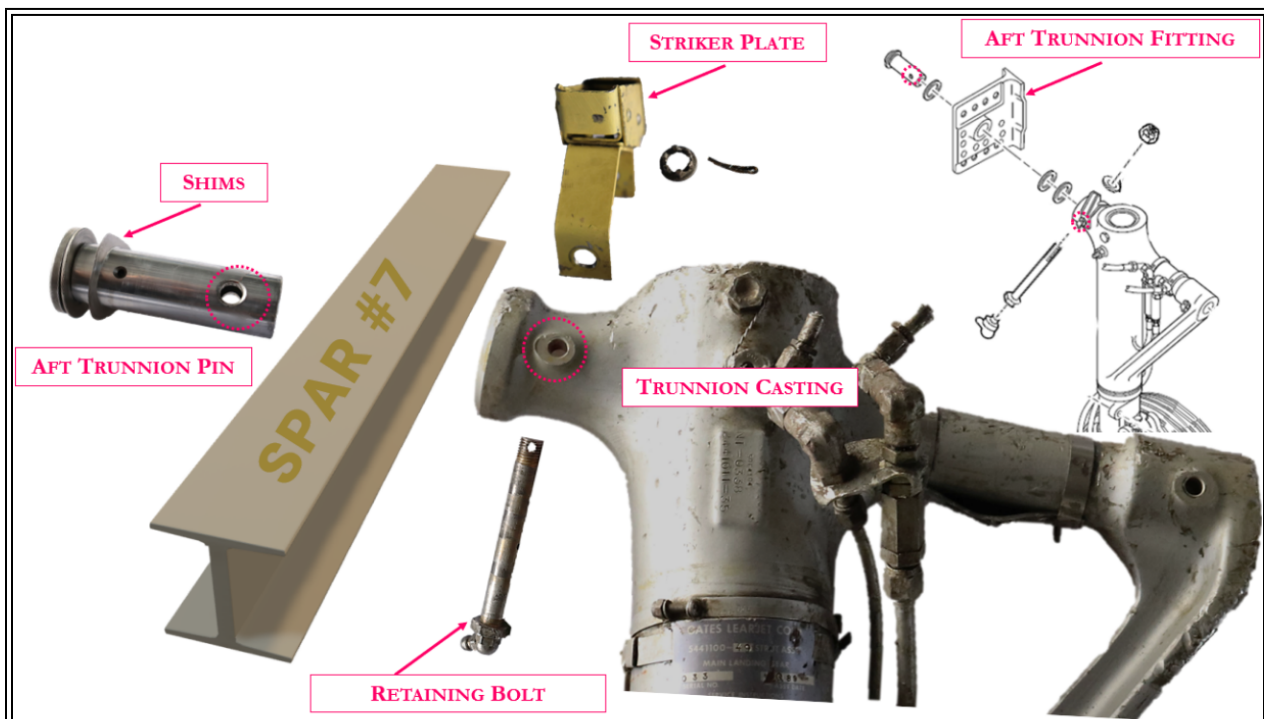
Figure 4: Left main landing gear assembly

The airplane is equipped with a retractable, tricycle landing gear that is electrically controlled and hydraulically actuated. Each main gear assembly consists of a conventional oleo shock strut, dual forged wheels with multiple-disc brakes, a main gear actuator, and inboard/outboard doors hinged at the wing structure. The assembly attaches to the airplane structure through trunnion pins, with striker plates on the trunnions to actuate microswitches. The aft trunnion pins are positioned with the shoulder abutting the aft trunnion fitting (located on spar #7) and the body is aligned forward through a bushing (where there is a grease hole on the pin) and into the aft trunnion casting (see figure 4). There are shims that are placed on the pin and positioned on both sides of the aft trunnion fitting to ensure adequate movement. The pin is secured to the trunnion with a retention bolt that goes through the striker bracket, trunnion, and the pin's retention bolt holes, which is then affixed with a castellated nut and cotter pin.
